# Your survey report

**Property address**  
1 High Street

**Inspection date**  
26th January 2024

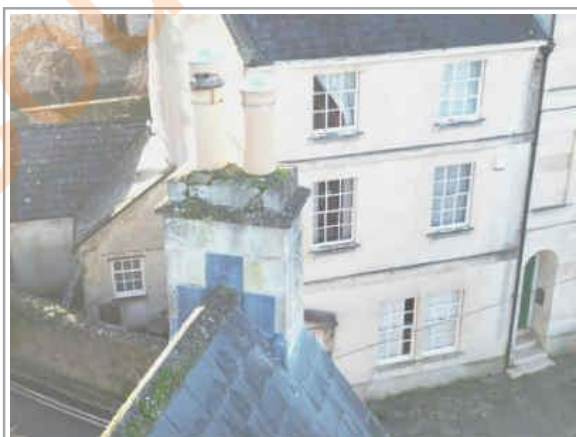
There is a stone built chimney stack to the left-hand side of section one. The chimney pots appear to be in a satisfactory condition and both have cowls to the top to prevent birds or rain from entering the flue. The lead was in a satisfactory condition. Pic.1

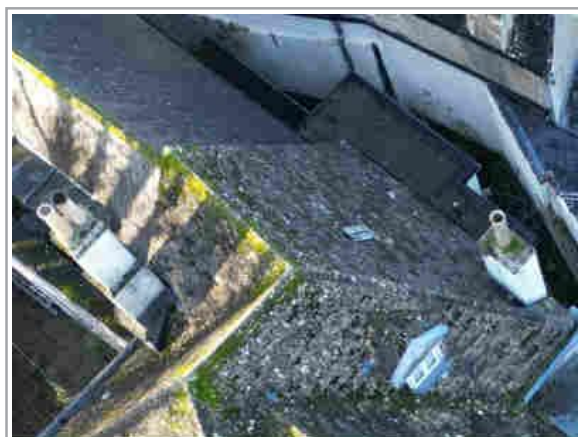
There are two stone built chimney stacks on section two. One to the front and one to the rear. There are two chimney pots on the front elevation. Both of these have cages to the top to prevent birds or foliage from entering the flue and no defects were noted. The lead was in a satisfactory condition. The single pot on the rear chimney stack is open to the elements. We would recommend a cowl is fitted to prevent any rainwater or foliage from entering the flue. Pic.2

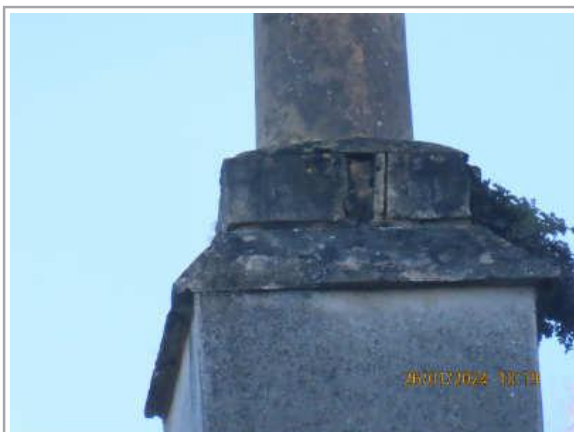
The benching around the rear chimney stack is covered in plants, cracked and loose in sections and some repairs and replacements are required. This should be carried out at the same time as the works to the roof whilst at this height. Pic.3

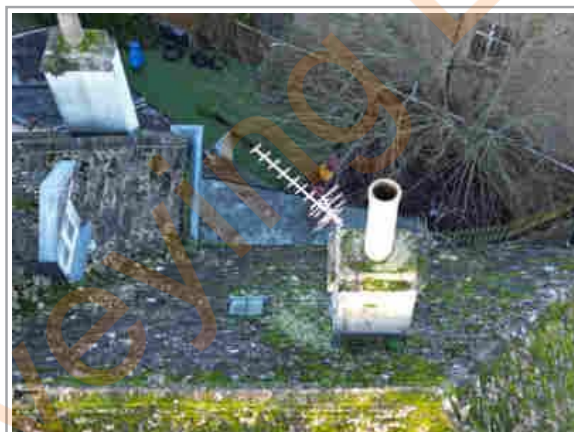
There is a single chimney stack and pot to the rear of section three. The stonework and lead were in a satisfactory condition. There is one open pot where a cowl should be fitted. Pic.4

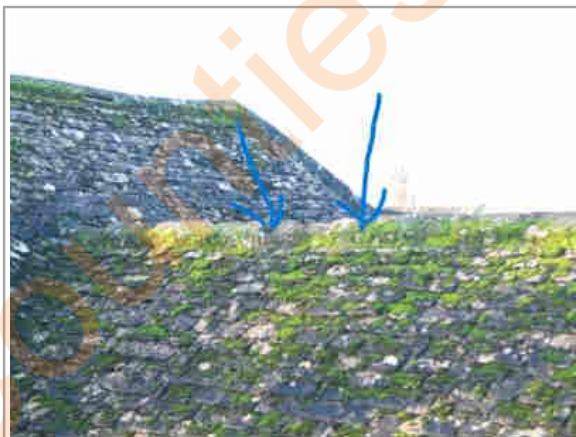
The stone ridge and hip tiles to sections two and three have seriously degraded in sections and there are some sections that are missing. This will be allowing moisture into the roof section which was unseen below. This has possibly caused some damage. Pic.1

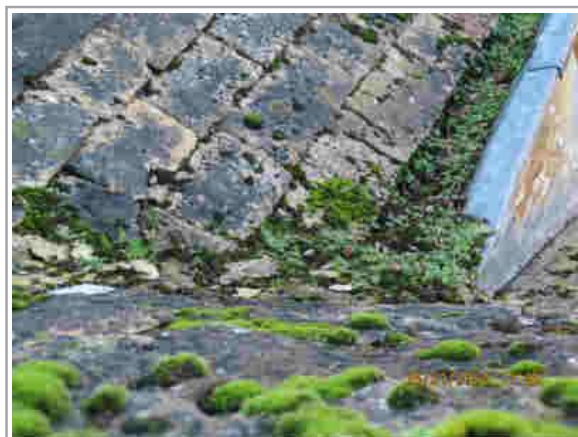
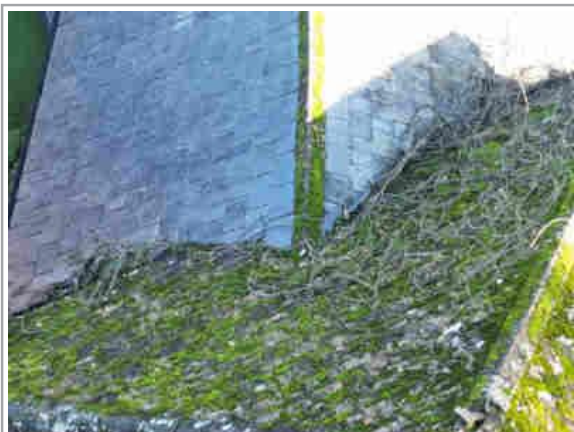
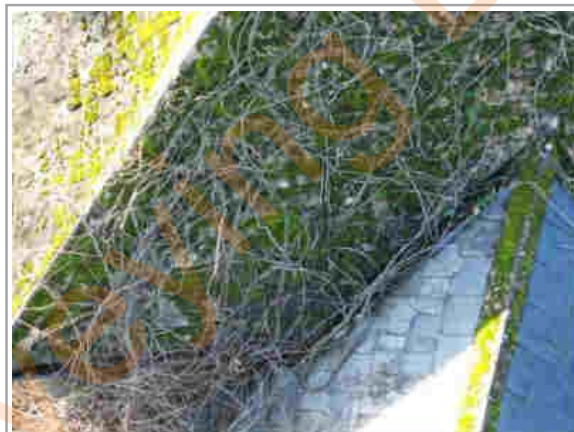
There is a considerable amount of moss and foliage on these roofs and there is obvious signs of degradation where the two roofs meet where there are stone valley tiles. Due to the amount of moss and the obvious damage, we strongly recommend that the roof is fully inspected by a competent roofing contractor before purchase and quotations are given for any necessary repairs. Please see Section I1 - Risks to the Building. Pic.2-4.

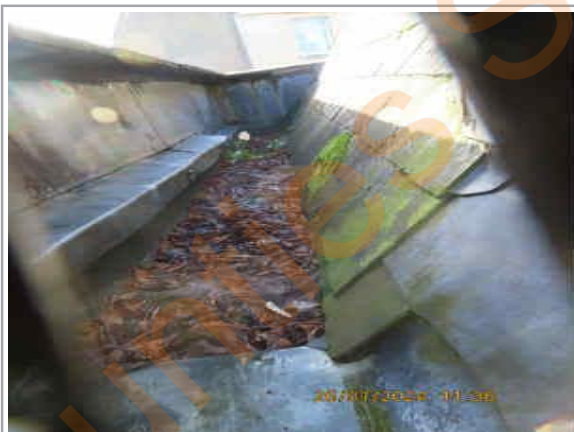
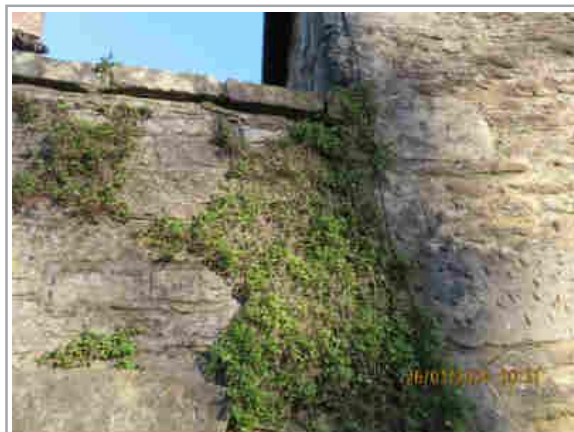
The parapet walls to the front of the property and the rear left-hand side over the entrance gate are covered in moss. Some degradation was noted on the front elevation due to this and the moss should be cleared off and any repointing carried out at the same time as the works to the roof. Pic.5-6

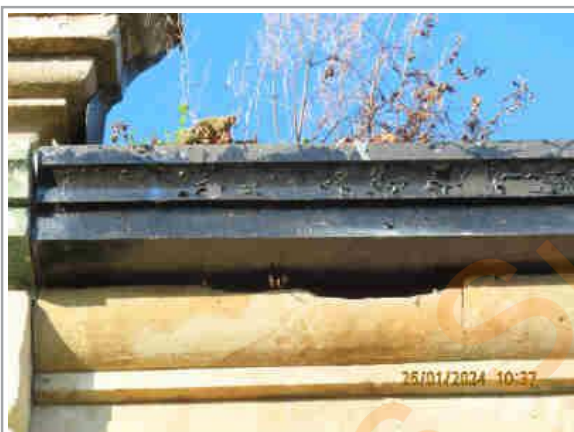
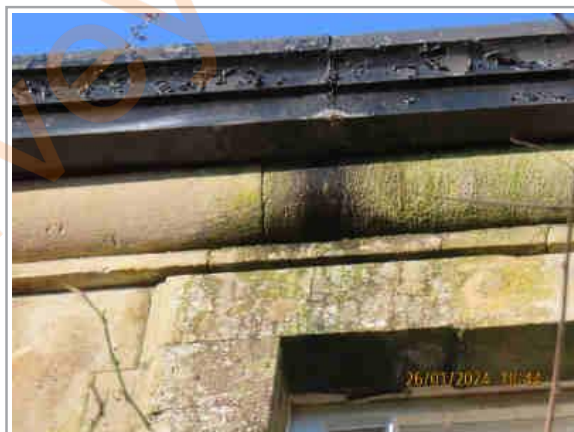
The metal gutters at the front elevation on section three are leaking around the joints. This has caused damage to the stonework below and damage to the internal surfaces. Please see Section E3 - Walls. Pic.1-2

The rainwater goods are in need of urgent maintenance and we would recommend that this is carried out as soon as possible. Please see Section I1 - Risks to the Building.

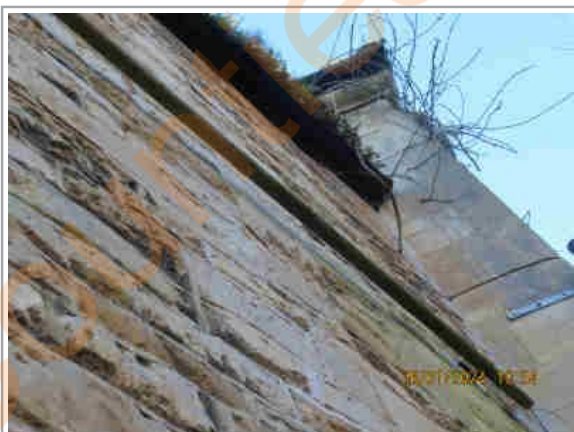
Blocked rear gutter

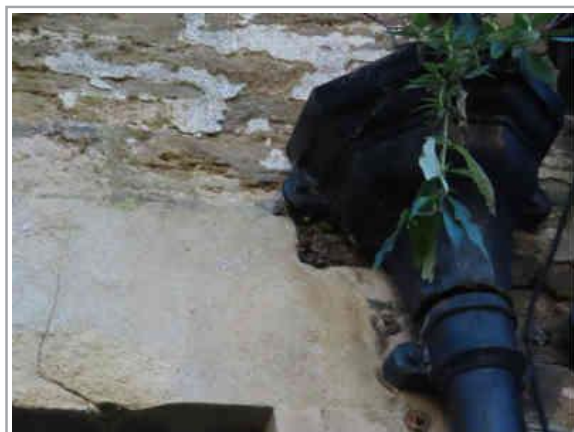
Blocked rear hopper

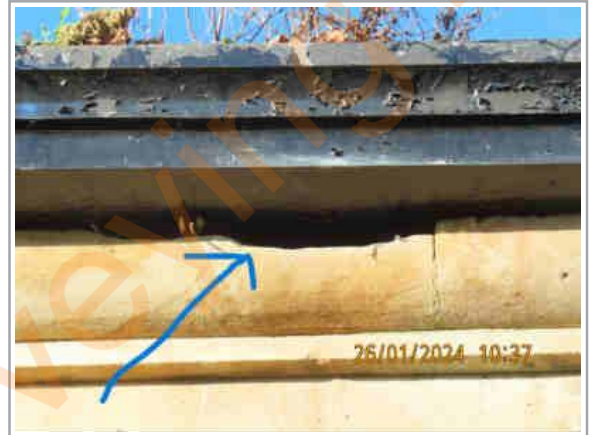
Below the gutter on the third section, there is a section of stonework missing directly under the gutter. It is unsure why this has occurred. Pic.2

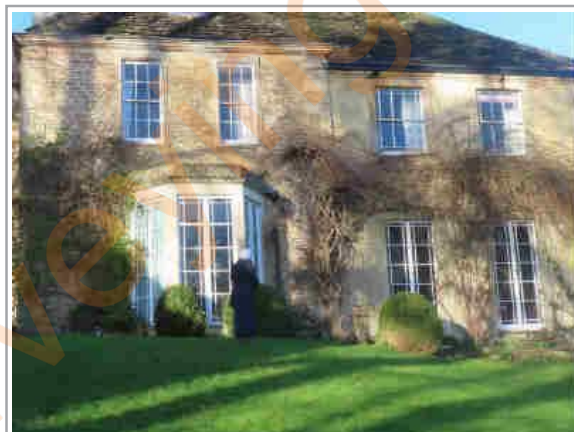
There are a considerable amount of creepers on the front elevation. If you wish to retain these, these do need to be cut back as they are causing damage to the stonework and to the roof and this should be trained away from the wall as soon as possible and regularly maintained.

Creepers to house

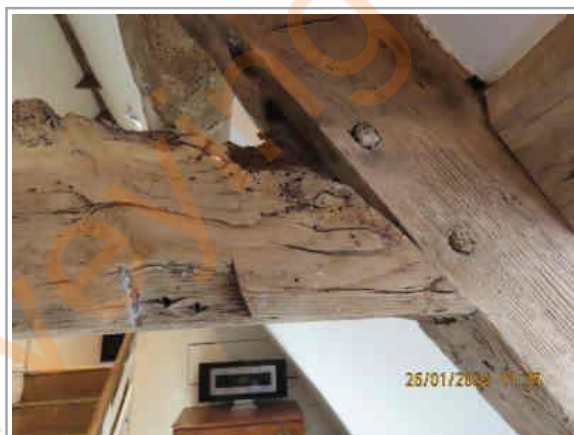
In section one where the cross beams enter the 'A' frames, there are some obvious signs of movement. Based on one visit we cannot confirm whether this is progressive or historic. The right-hand side 'A' frame where the collar reaches the front section, this has moved considerably. This may require some strengthening works in the future. This should be regularly monitored. If any further movement occurs, you will need to instruct a Structural Engineer immediately. Pic.2

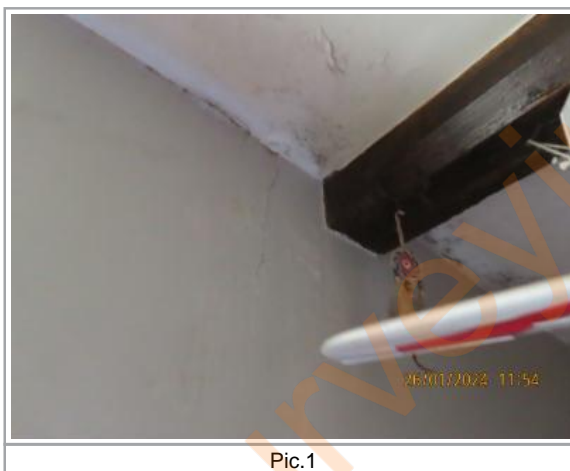
There is damage to the ceiling in the sitting room and the games room above. This is due to a leak from the blocked parapet gutters. Some replastering will be required in these sections. Pic.1

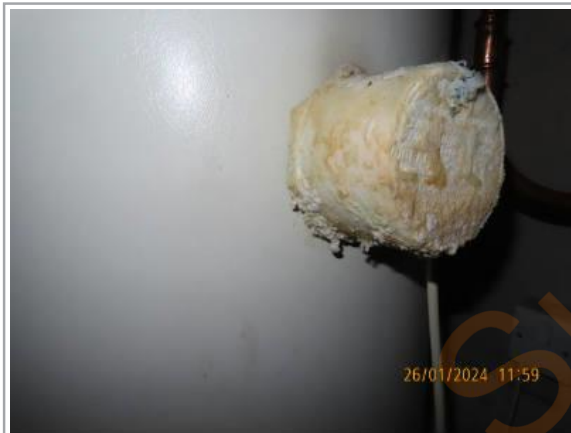
Furring was also noted around one of the immersion heaters on the front of the cylinder. This is possibly due to the leak. The cylinder is a modern design.

Furring on heating element

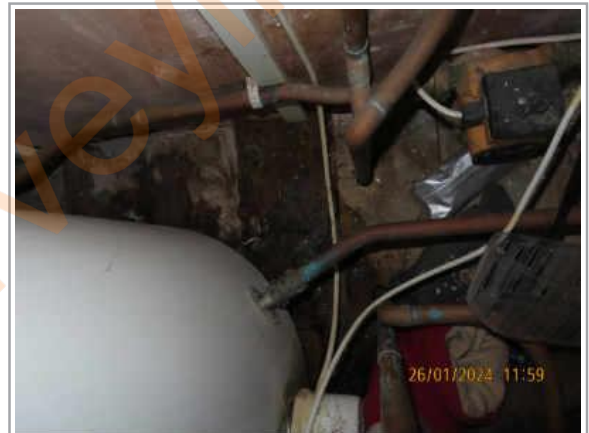
Leak on cylinder

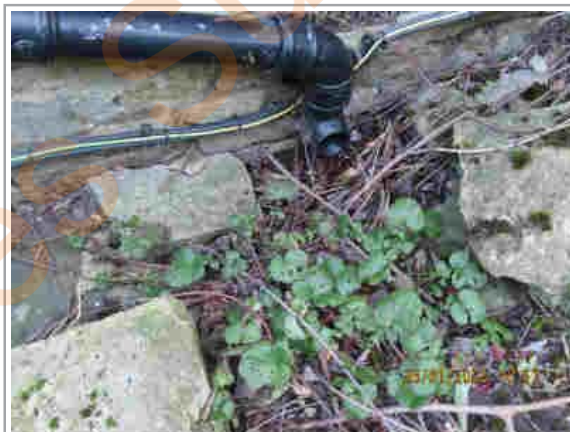
Blocked gully
