# Your survey report

1 Any Street, Melksham, Wiltshire, ME5 8DH

3rd October 2022

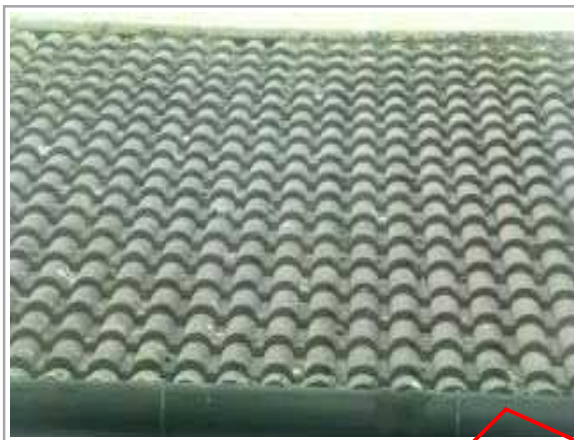
Front elevation roof

The roof, where visible, was free from any signs of significant defects. There were no slipped, cracked or missing tiles where visible.

Moss was evident to the roof. This should be carefully cleaned with a soft brush to prevent blockages to the gutters and drainage below. Further defects may become evident when the moss is removed.

The ridge was flat and level and free from any signs of significant defects. A closer inspection may reveal that some minor repointing is required after the moss is removed. This will prevent any water penetration to the roof void internally although none was noted at the time of our inspection.

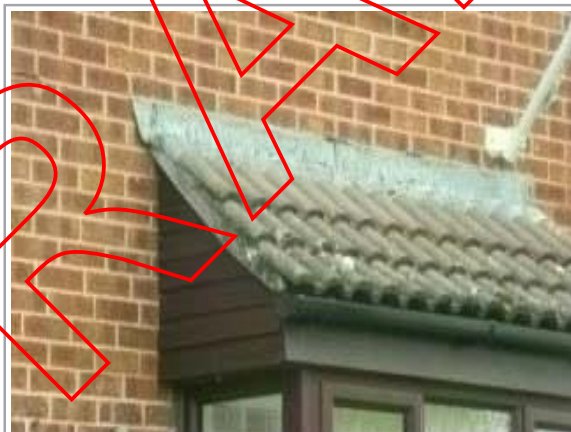
Bay roof

There is a small mono-pitched roof above the front bay window. This is clad with concrete interlocking tiles which was free from any signs of significant defects. The moss should be cleared at the same as the main roof. The lead was securely fixed and in a satisfactory condition.

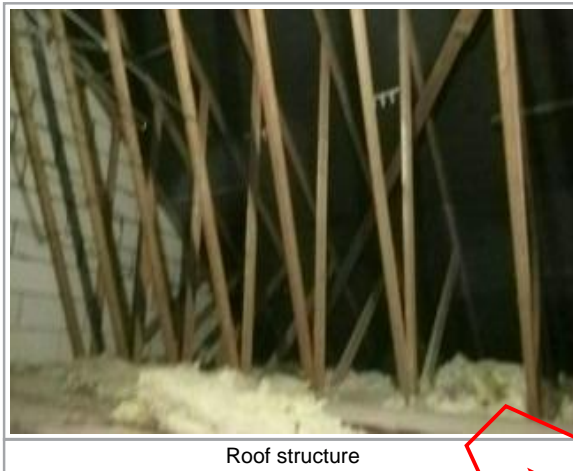
Roof structure

The roofing felt beneath the main roof covering is a type 1F sarking felt, commonly used in this situation, and becomes brittle with age. It has a tendency to rot at the eaves and if not properly supported, the rear of the fascia and top side of the soffit boarding will become damp and provide conditions for wet rot to occur.

Our inspection revealed no evidence of any significant rot or active wood-boring beetle infestation.

No significant signs of condensation were noted to the roof void which appeared to be vented satisfactorily.

200mm of insulation is present in the roof void. It is recommended a minimum thickness of 270mm fibreglass quilt or similar insulating material is provided over all areas. A 50mm gap should be left at the eaves sections to allow for ventilation to the roof void if the roof is vented to the eaves. This should be carried out by a competent contractor.

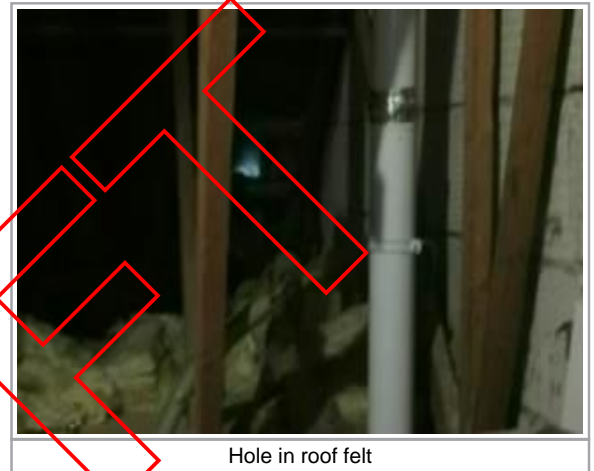
Hole in roof felt

One hole was evident to the front left-hand side corner of the roof void where daylight was coming through. No other holes were noted and it may be possible to patch repair this in the short term, however you may wish to obtain quotes before completion, so that you are aware of your future liabilities.

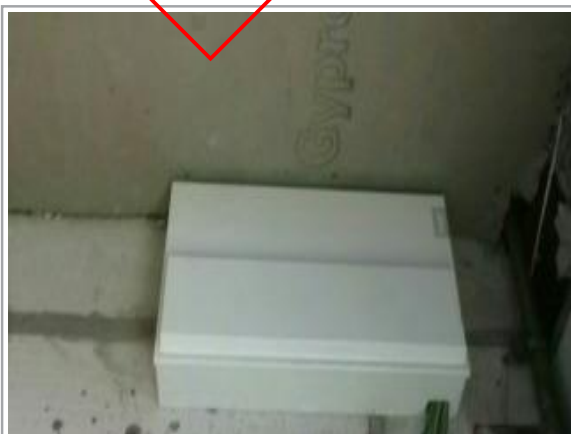
Consumer unit

Recessed light fittings were noted to the property. These should be checked to ensure that fire hoods are fitted above them.

We have not arranged for a specialist test of the electrical installation and are unable to comment upon it in detail. Without such a test it is not possible to say whether the installation is safe and complies fully with current regulations.

If a recent test certificate is not supplied you should have the entire system, including, but not limited to boilers, immersion heaters, electric fires, electric radiators, electric showers and electrics in the garage and external electrics, if they exist, checked by a competent electrician (NICEIC/ECA registered) prior to purchase. The installation should be re-tested every three years or in accordance with current regulations. (Please see Section I1 - Risks).

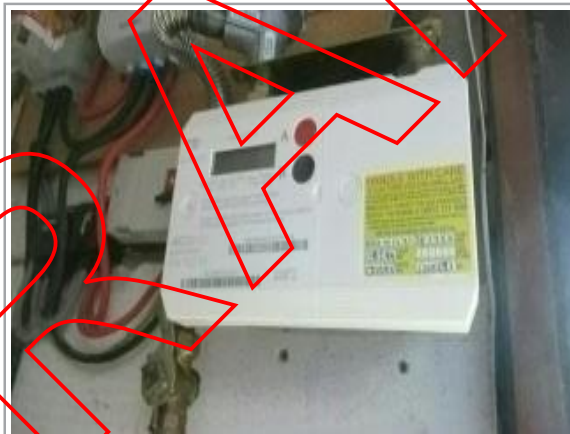
Gas meter

We have not carried out any test at all or inspection to the gas. This must be tested. If a 12 month gas check certificate is not in place then you must ensure one is carried out before use. Please see Section I1- Risks.

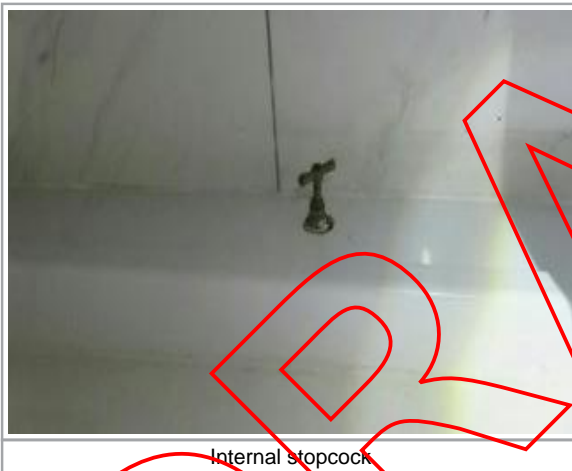
Internal stopcock

An internal stopcock was noted in the downstairs WC. We have not tested this.

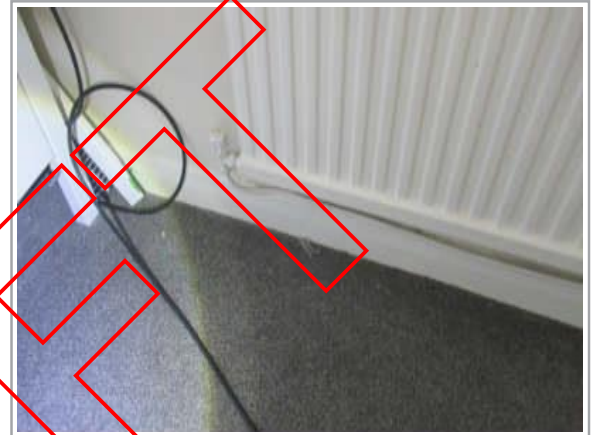
Microbore pipe

Microbore pipework was identified. You should be aware that this is likely to be of some age and given the small diameter of the pipes is more likely to suffer from blockages and require remedy, particularly in hard water areas.

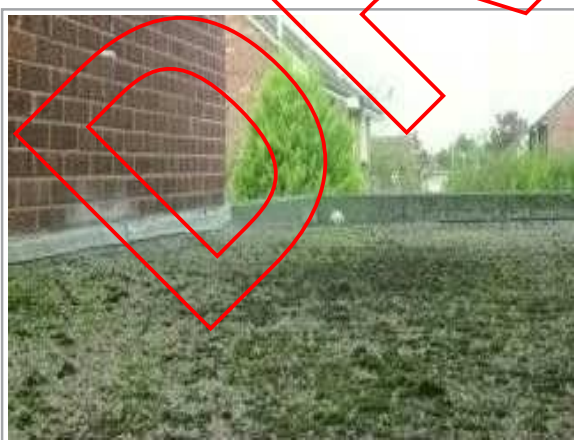
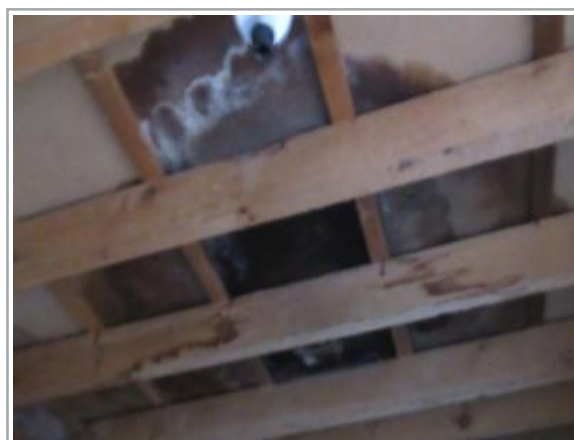
leaks to garage roof

Bituminous felt coverings to flat roofs typically have a life span of 10-15 years. Leaks were evident.
