# Your survey report

**Property address**  
1 High Street

**Inspection date**  
26th January 2024

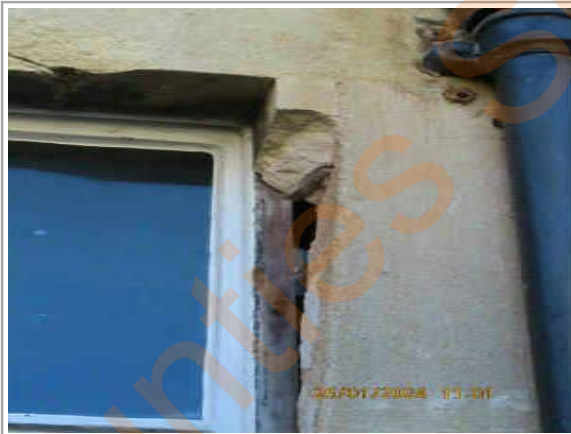
Pic.3

Behind section two, around the ground floor window, to the hallway, there is a section of stonework that has fallen out next to the sash window and this is now allowing daylight and rainwater into the building. Pic.3. There is also a minor crack on the lintel and the window sill.

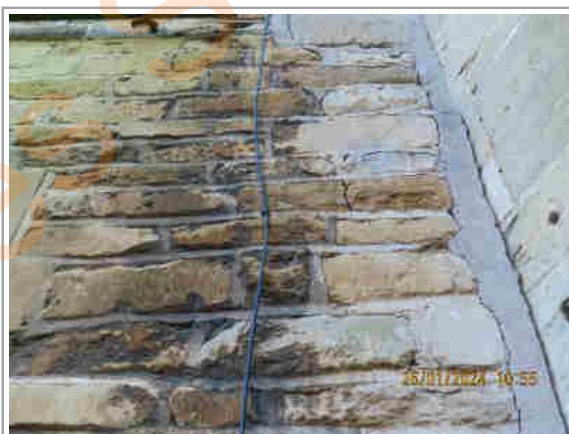
Where section two joins section three to the rear, there is a cement fillet. A crack of approximately 2-3mm has occurred against this join. This is more likely due to the sand and cement cracking rather than movement. It will become worse over the years and whilst the other works are being carried out, this section should be removed and repointed with a lime sand and cement. Pic.6

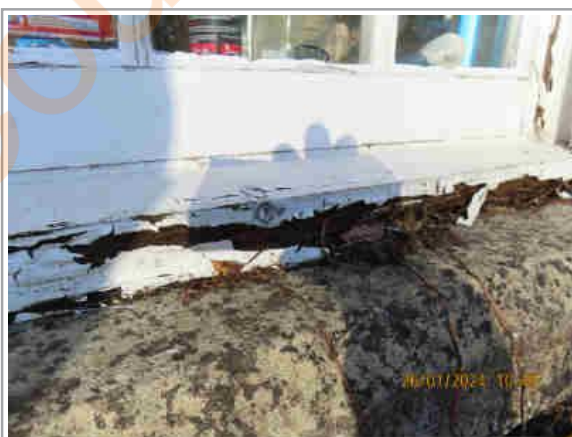
The window sills to section five on the front elevation have completely rotted. These require repairs or even possibly replacements. Pic.3

Due to the amount of decay to some of the windows and the cracked panes of glass, we would recommend a general overhaul is carried out to all of the windows as soon as possible to prevent any further damage to the building. Please see Section I1 - Risks to the Building.

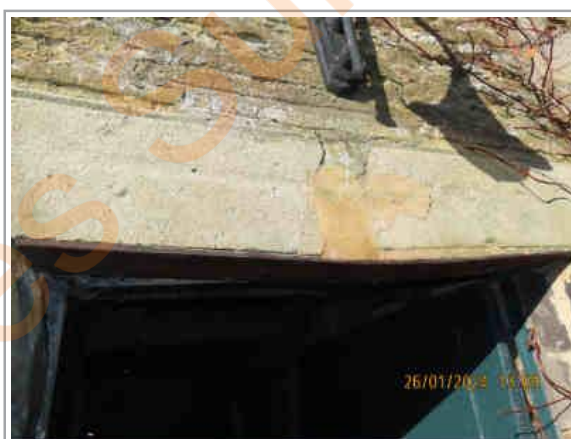
The stone lintel above the front door has dropped with a metal plate holding it up beneath but the metal plate has no bearing either side, therefore is not acting as a support. Pic.3

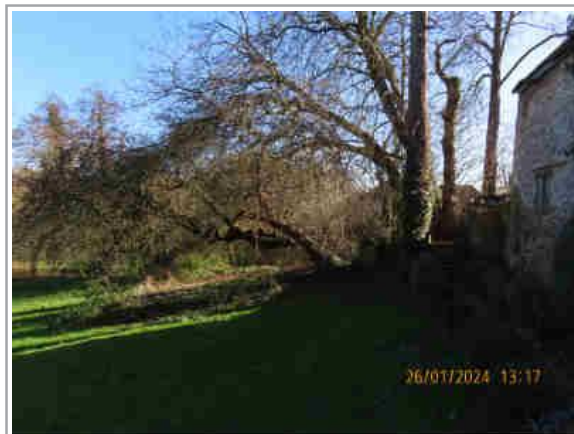
There are a considerable amount of trees surrounding the property. Unless you are use to the costs of maintaining trees, you should obtain an arborist report before purchase so you are aware of your financial liabilities. There is a large tree at the back of the car park which is leaning heavily over the garden. This requires attention we would have thought within the next year to prevent any possible injury. Pic.4

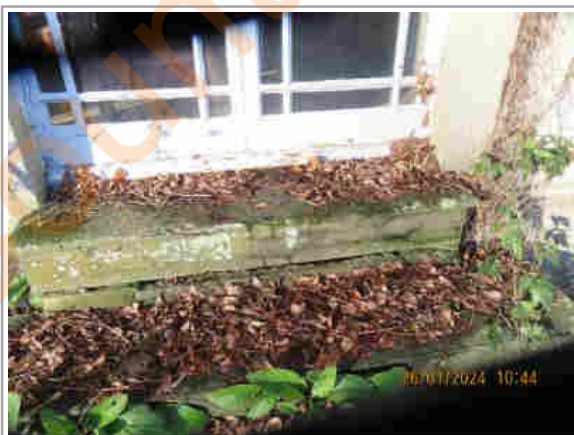
On section three of the main property, there are stone steps leading from the French windows. The stone steps have dropped probably due to some land subsidence beneath or poor footings when they were constructed. These will probably continue to move over the years and you should look to carry out some strengthening works or replacements to this area. Pic.5

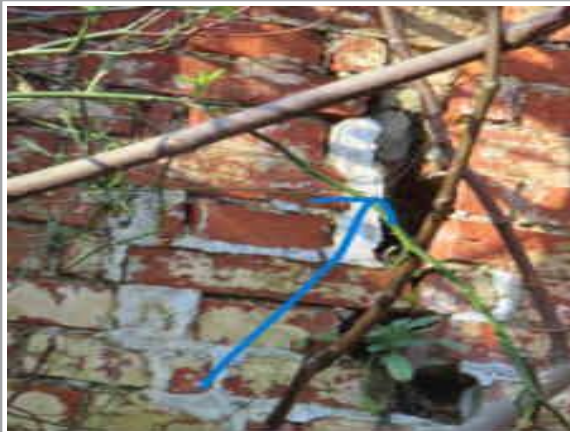
There is a significant amount of movement noted on the top of the brick wall to the right-hand side of the stone columns. This will require some strengthening work depending on who owns this section. If it belongs to the subject property, you should obtain quotations for rebuilding or strengthening work as this may prove to be costly. Pic.7
